# **Fatigue and Damage Tolerance Requirements of Civil Aviation**

**Dr. Patrick Safarian, P.E.  
FAA Senior Technical Specialist**

**Winter 2014**

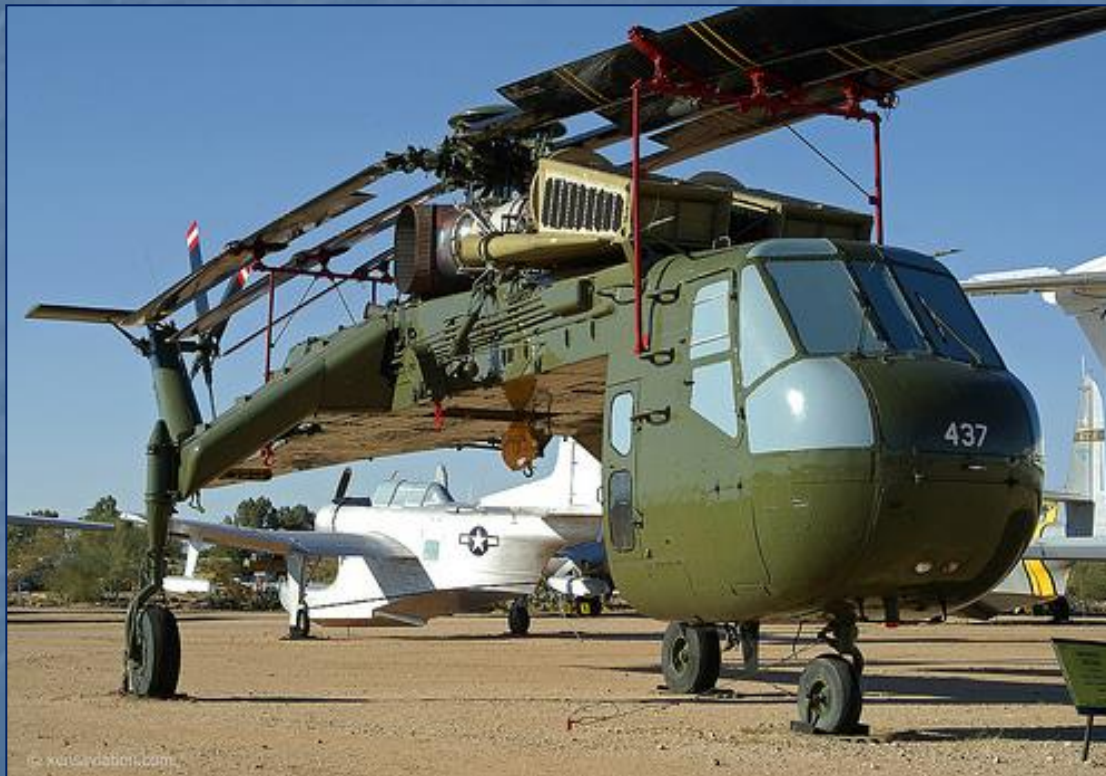
- Catastrophic loss outer 3 meters of CH54A main rotor blade on July 18, 1998.

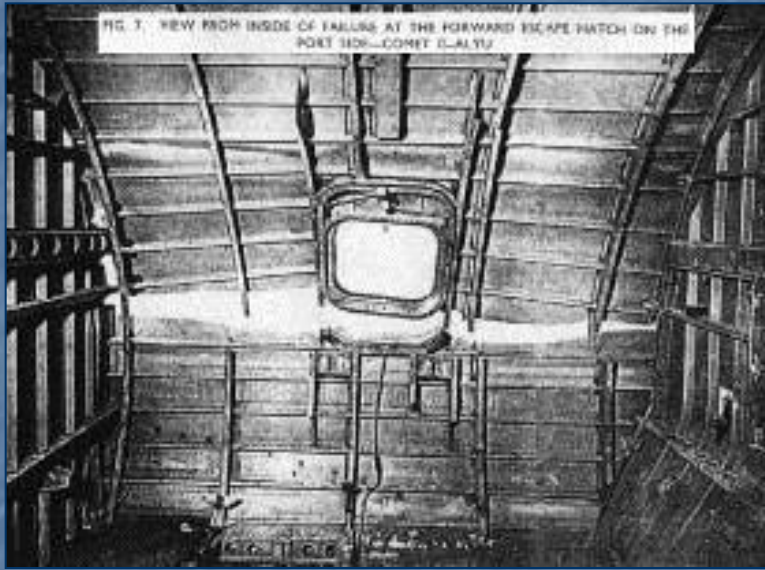
In the test ~3,600 flight cycles  
4.5m section of the fuselage at  
Escape Hatch the ruptured

G-ALYP sections  
recovered from the  
sea confirmed the  
test results; in this  
airplane the crack  
was at the ADF  
Aerial Window

- Airplane was certified as safe-life for 16,000 flights and 10 years of utilization.
- Operational Pressure higher than existing airplane models of the time
  - $P=8.25$  psi compare to  $\sim 5$  psi
- Full scale test to 30 times up to or near  $2P$  plus 2000 times higher than  $P$ 
  - Designed for  $2.5P$
- As a result of high applied  $P$  many fatigue critical details were plastically deformed
  - Caused an artificially long fatigue life

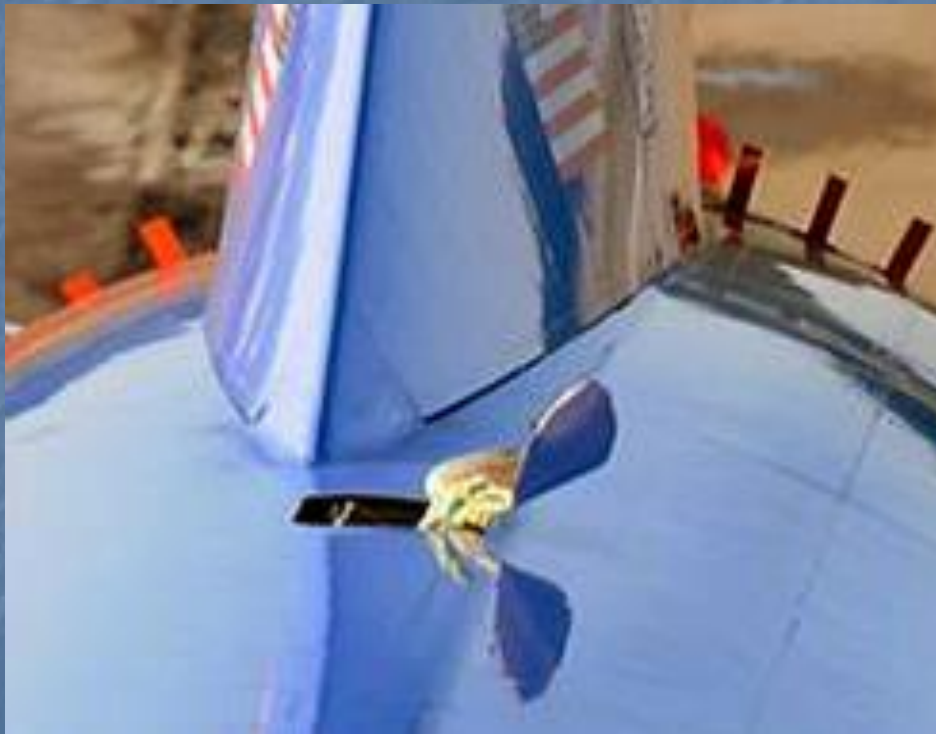
- Chem-mill pockets in fuselage skin cause eccentricity, which is a source of additional bending stress that can lead to early cracking.
